# **Inquiry into the Explosion and Fire at Icepak Coolstores, Tamahere, on 5 April 2008**

**Incident Number F128045**

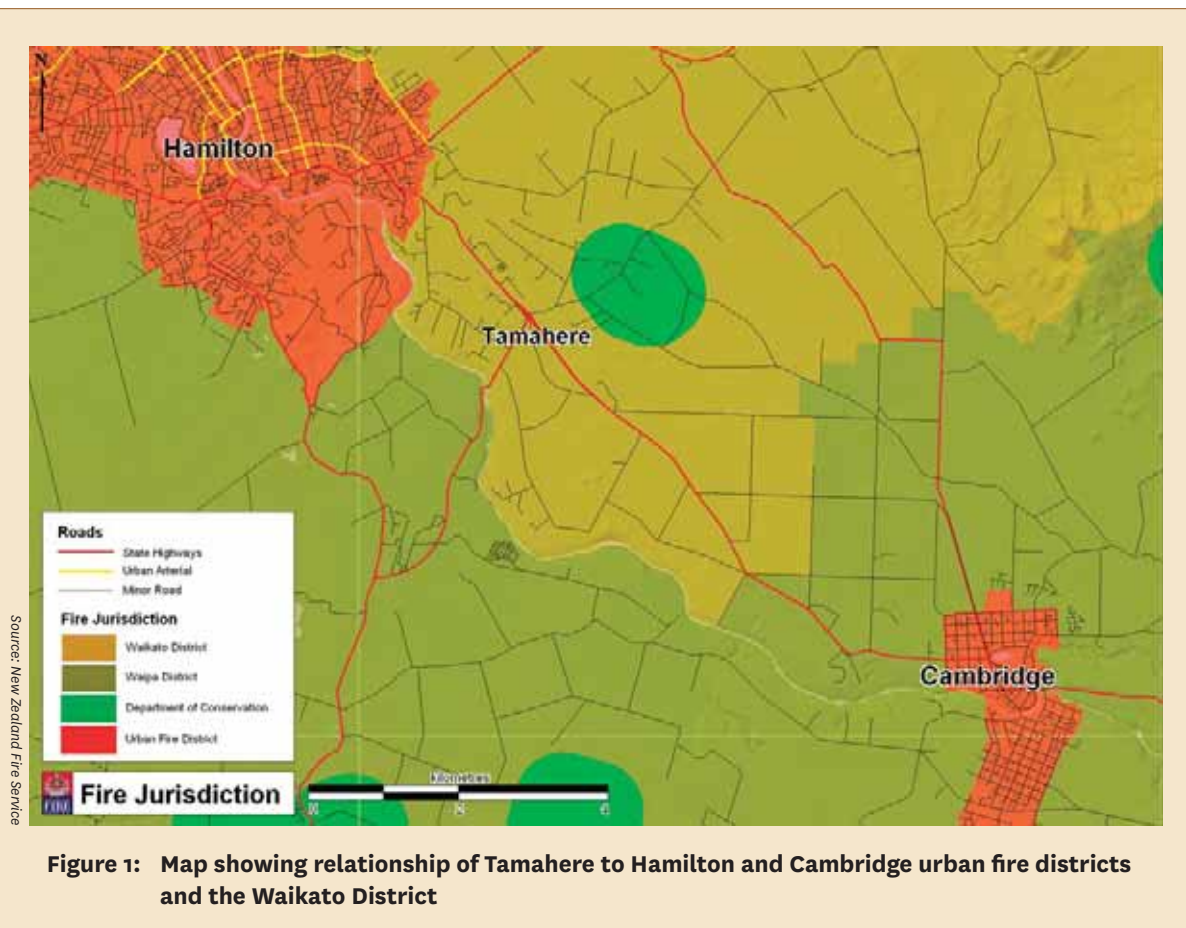
**Figure 1: Map showing relationship of Tamahere to Hamilton and Cambridge urban fire districts and the Waikato District**

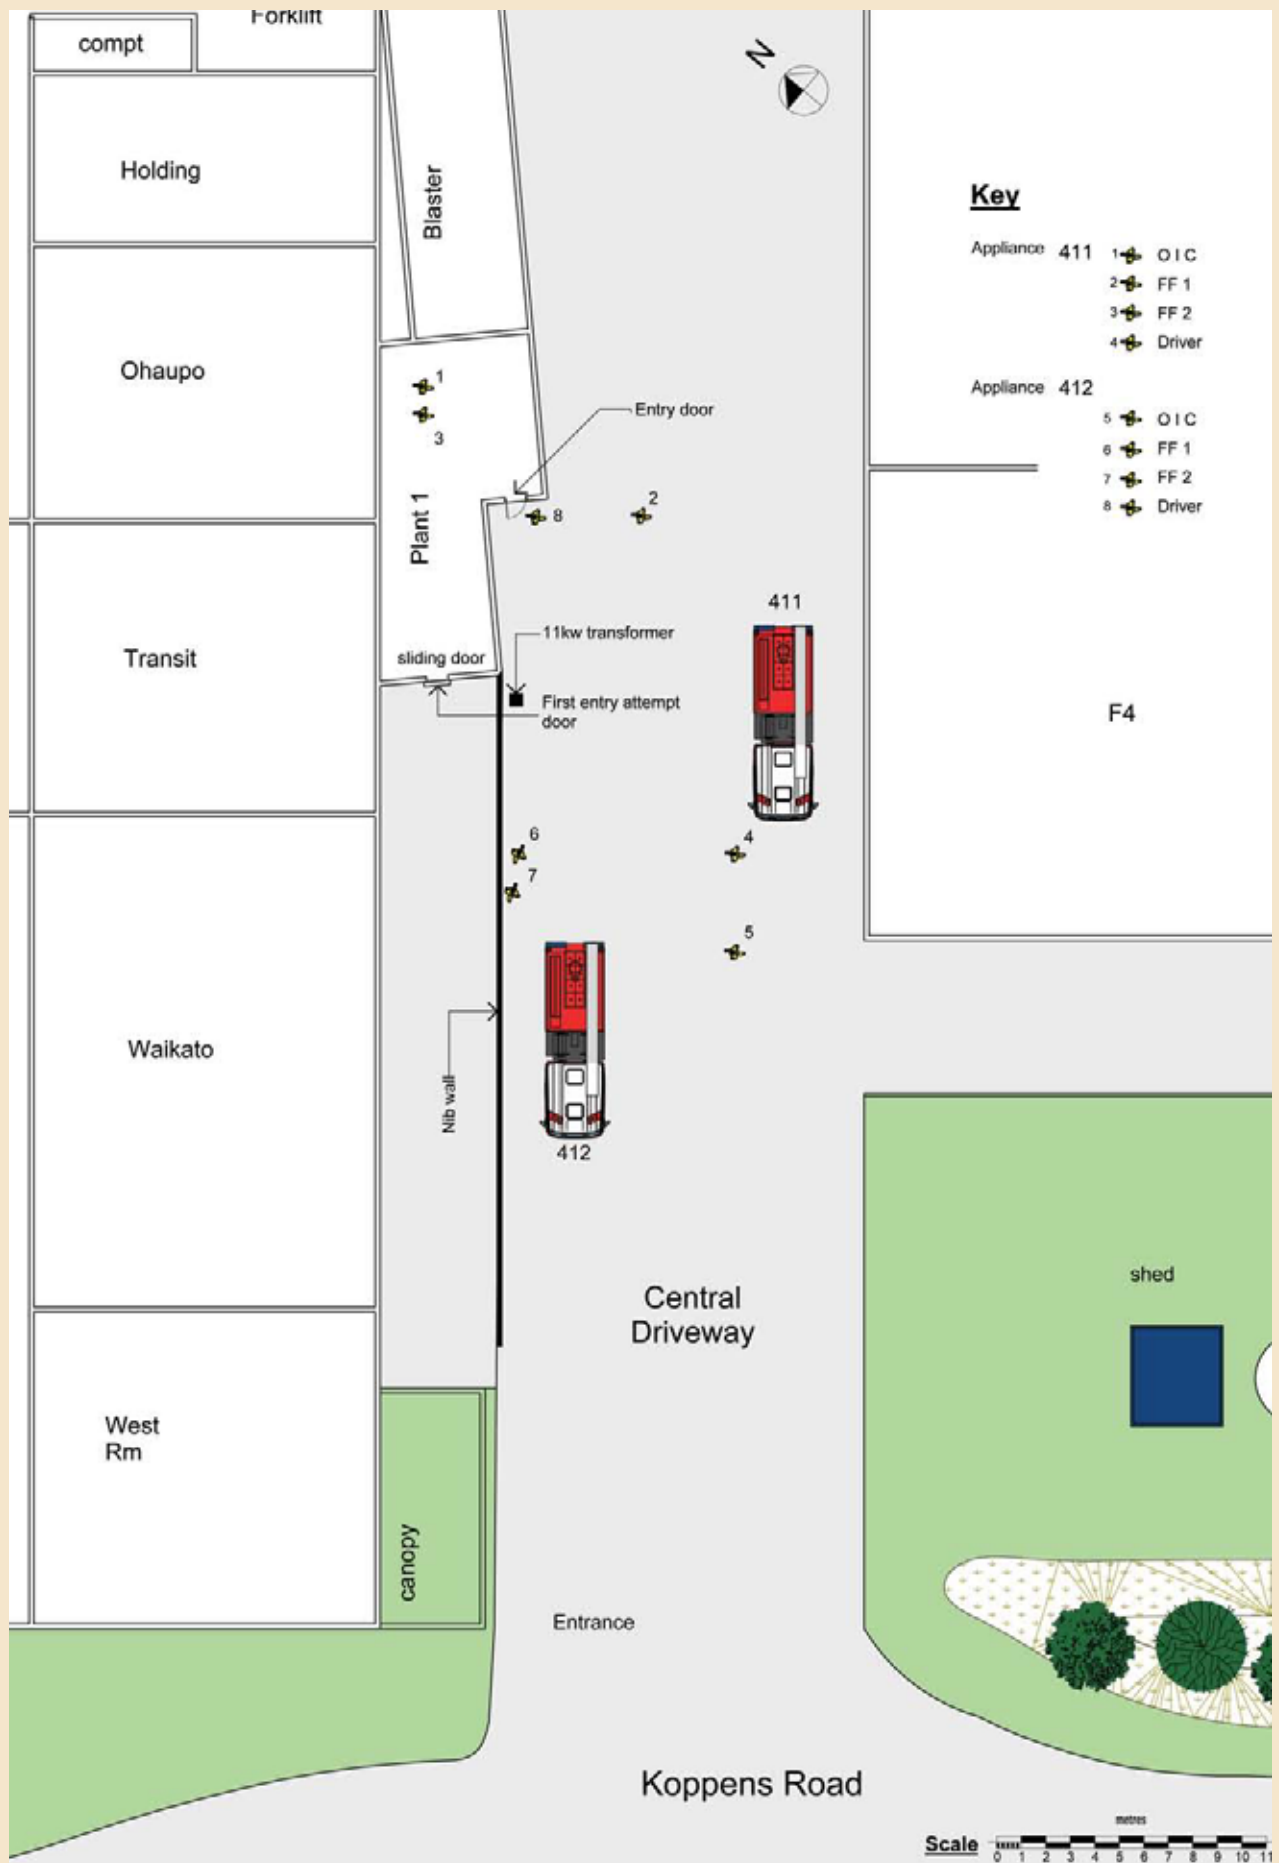
Figure 4: Firefighter positions at the time of the first explosion, deduced from transcripts of interviews

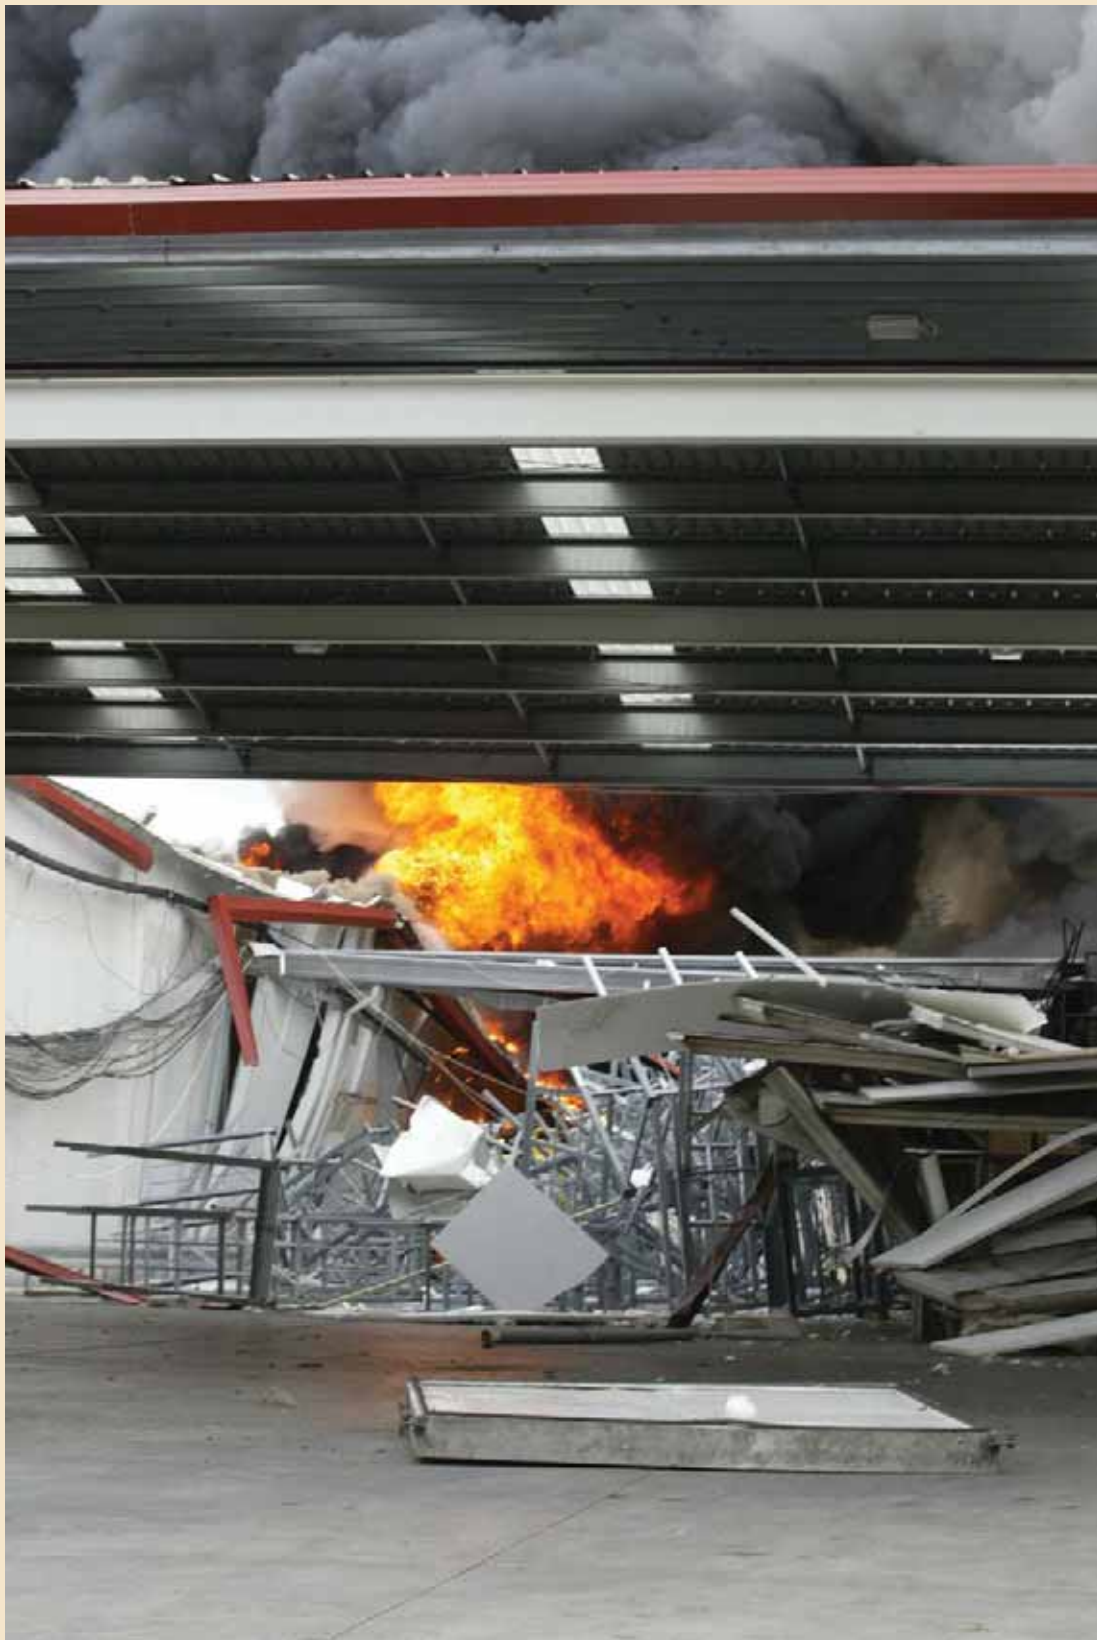
Source: Christine Cornege, Waikato Times

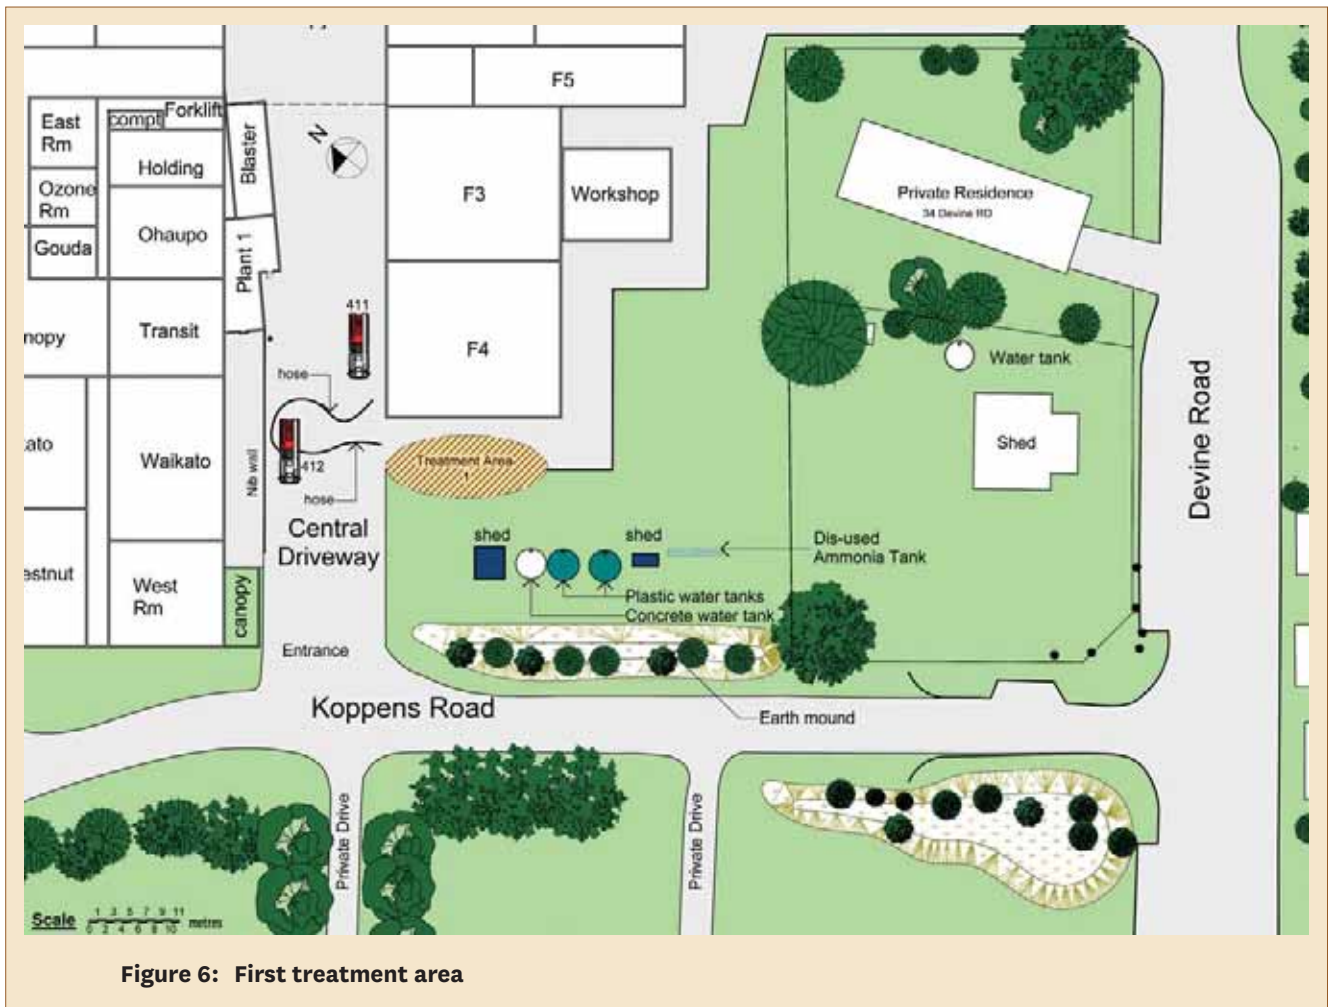
**Figure 6: First treatment area**

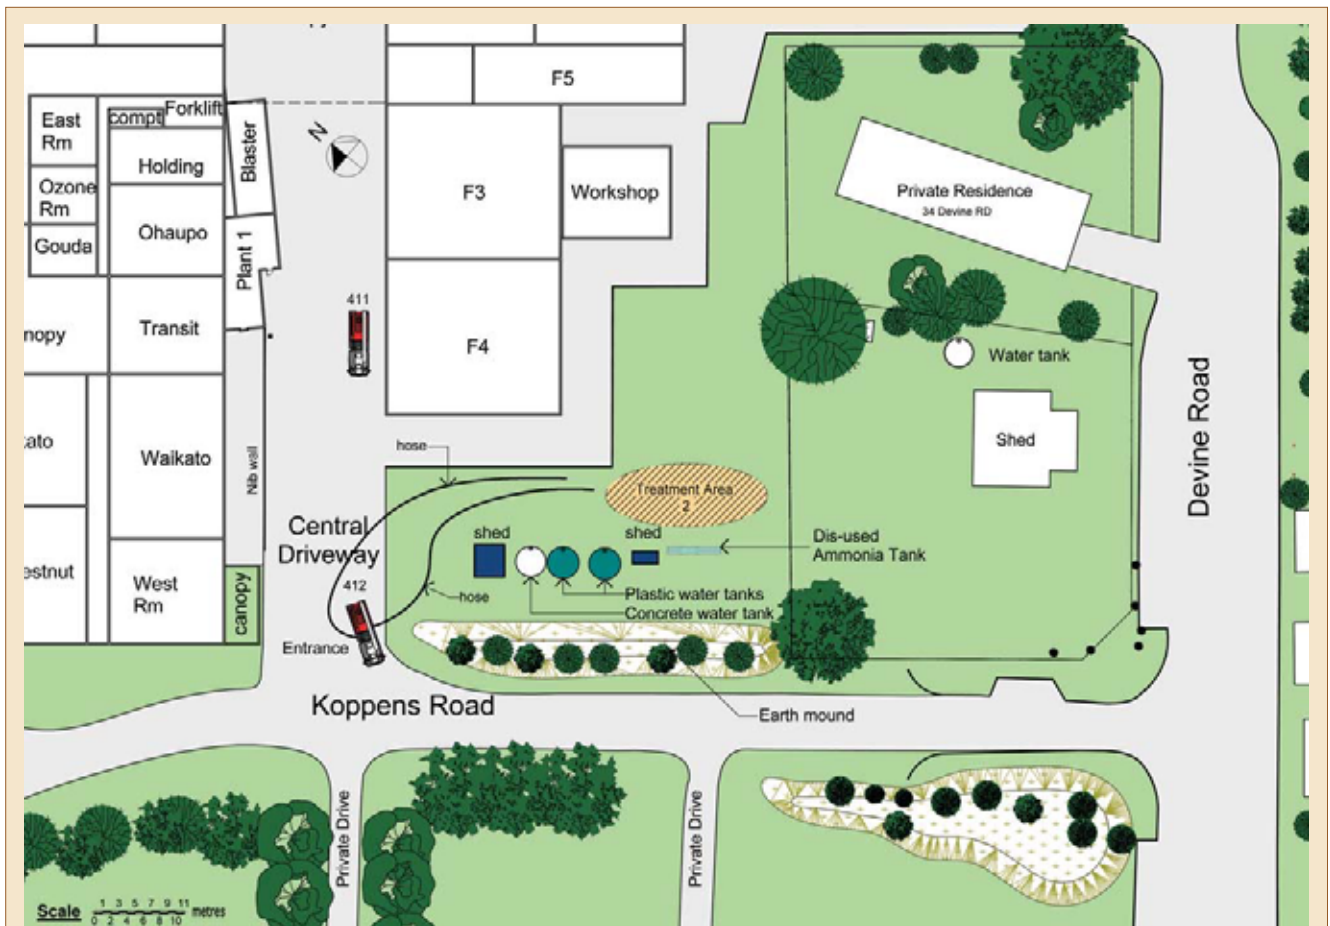
Figure 7: Second treatment area

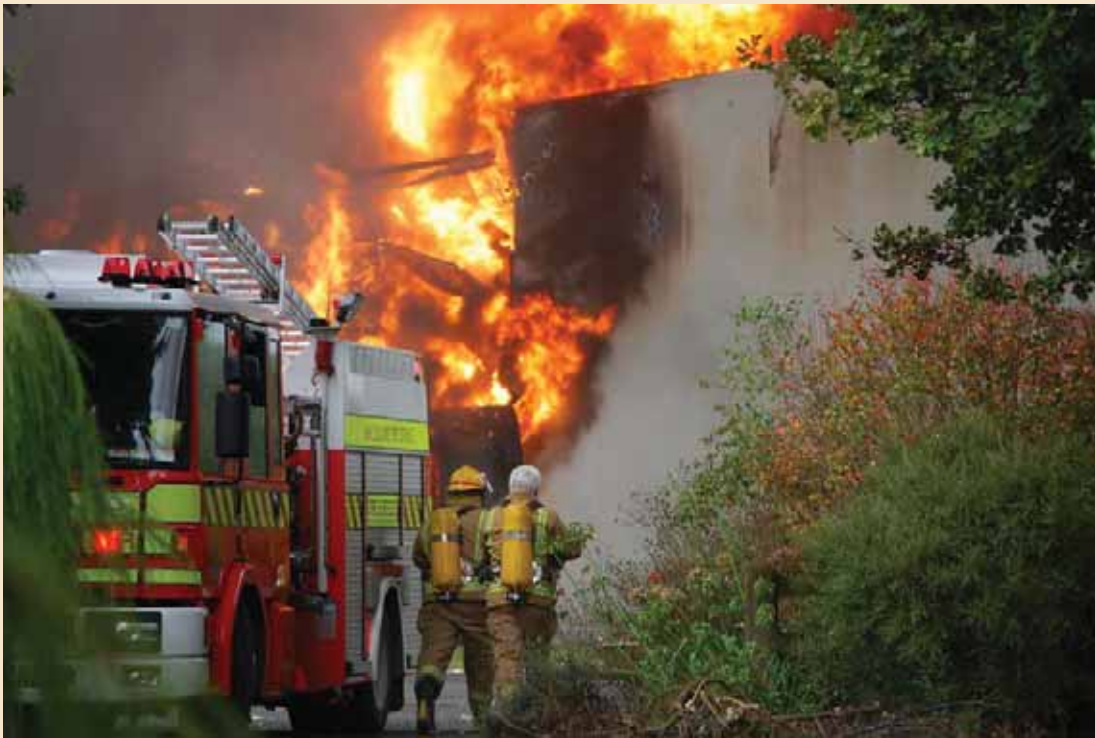
**Figure 9: The fire as confronted by Pukete 431 when the appliance halted – 12 minutes after the explosion**

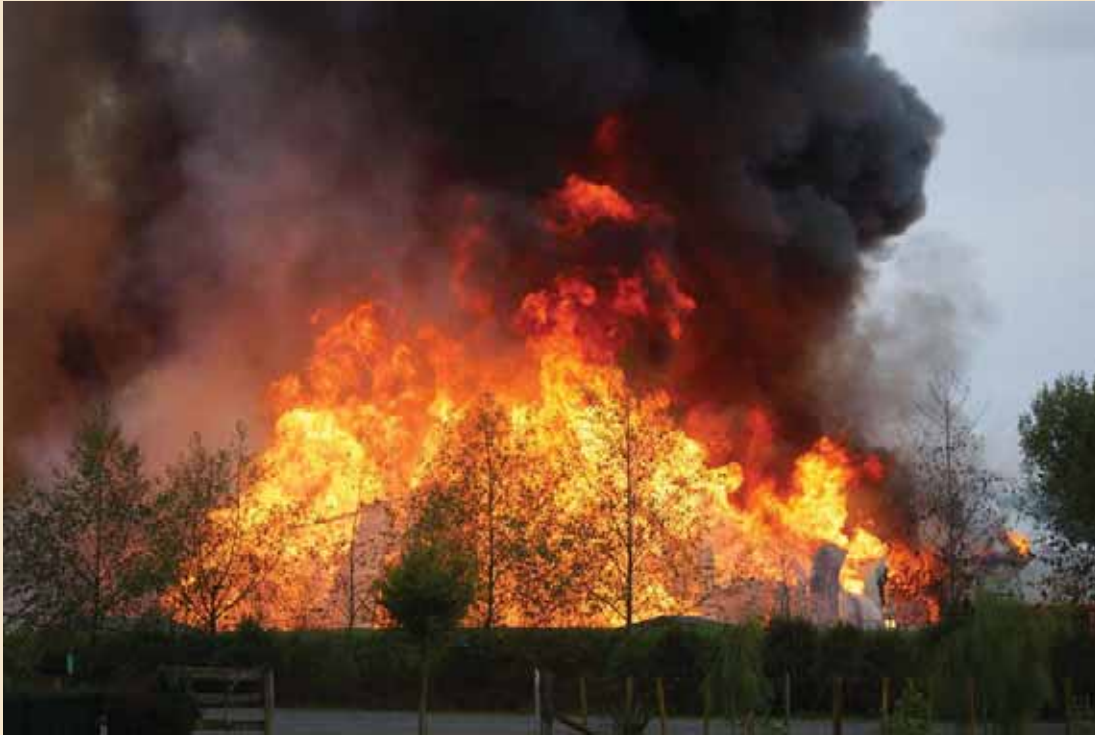
**Figure 12: Fire size just after Hamilton CFO arrived**  
Coolstore walls of Room F4 have failed.

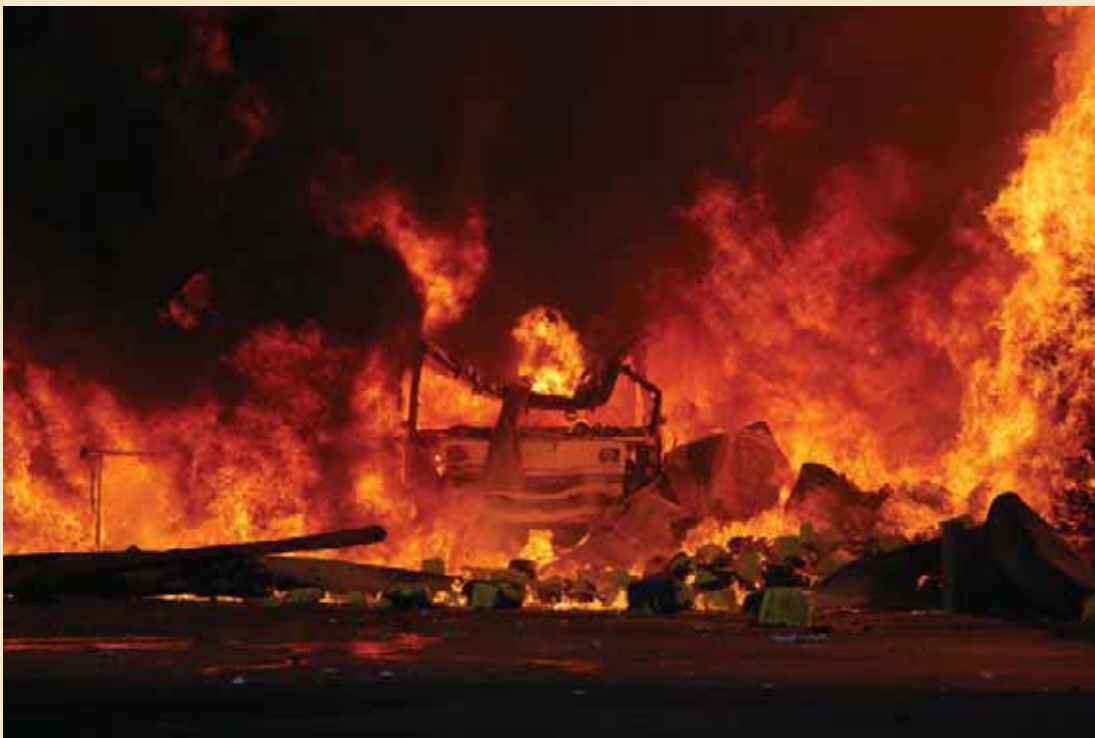
**Figure 13: Last picture of Hamilton 411 at about 17:10**

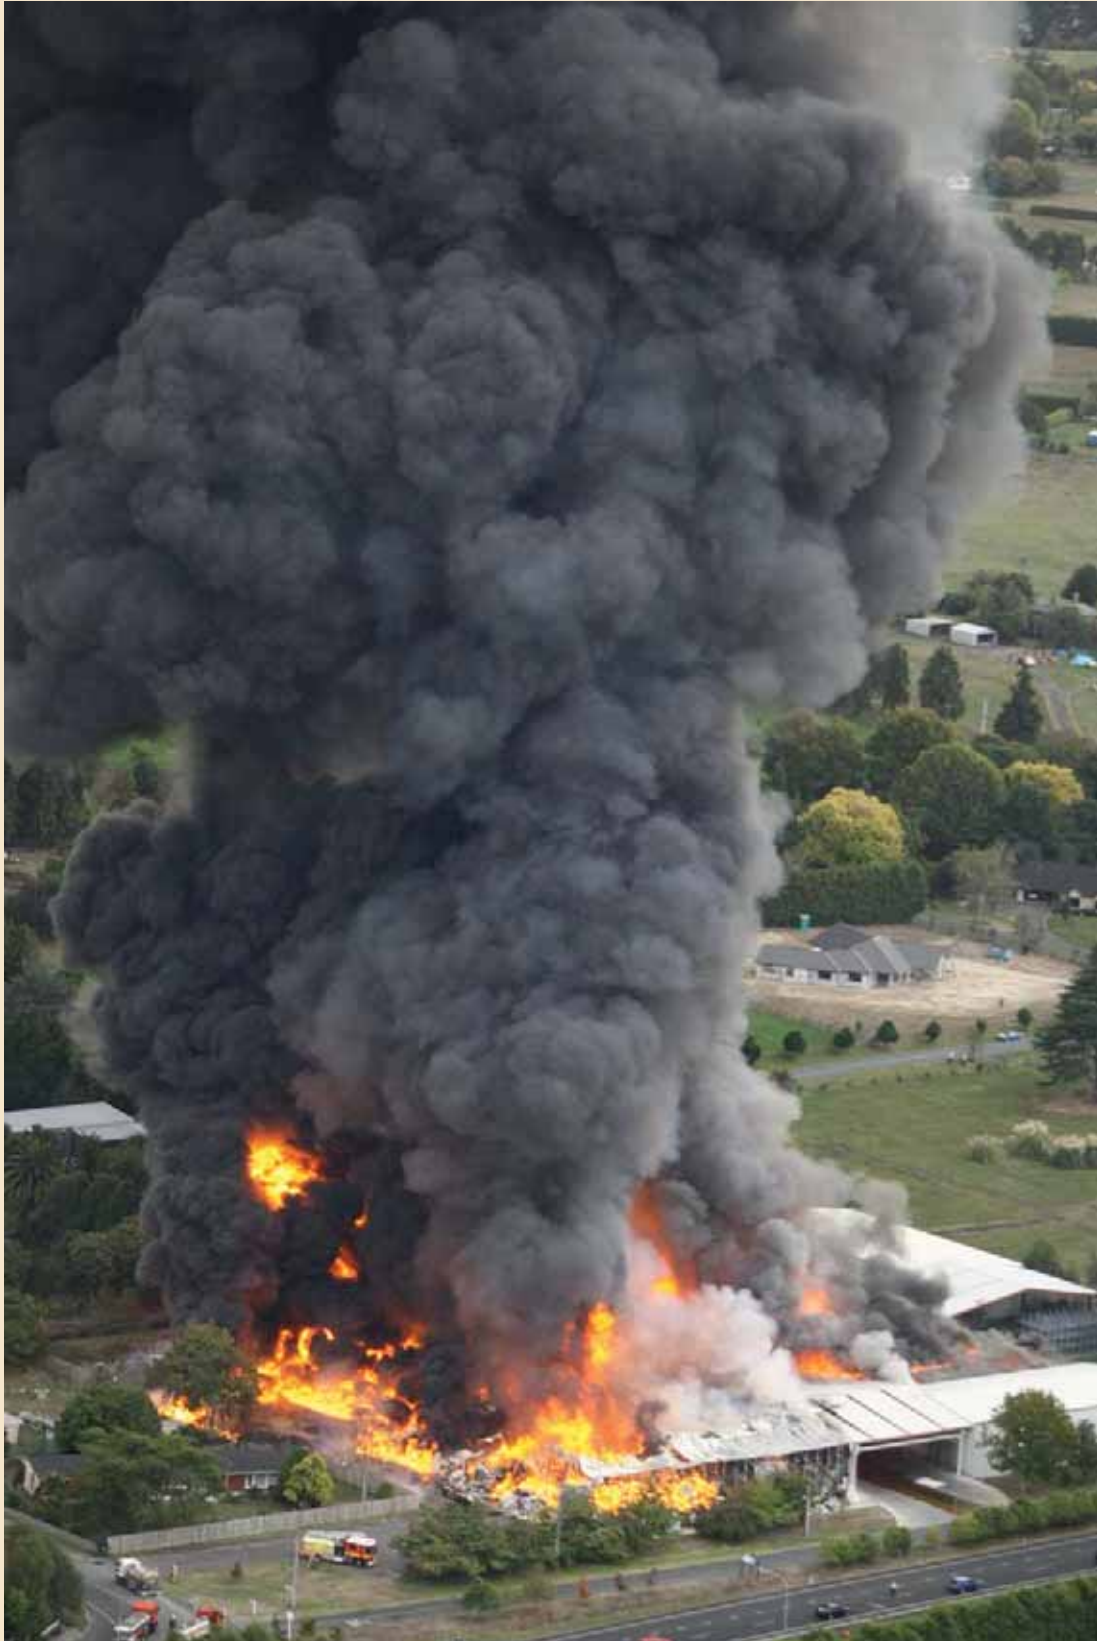
Source: Christine Cornage, Waikato Times

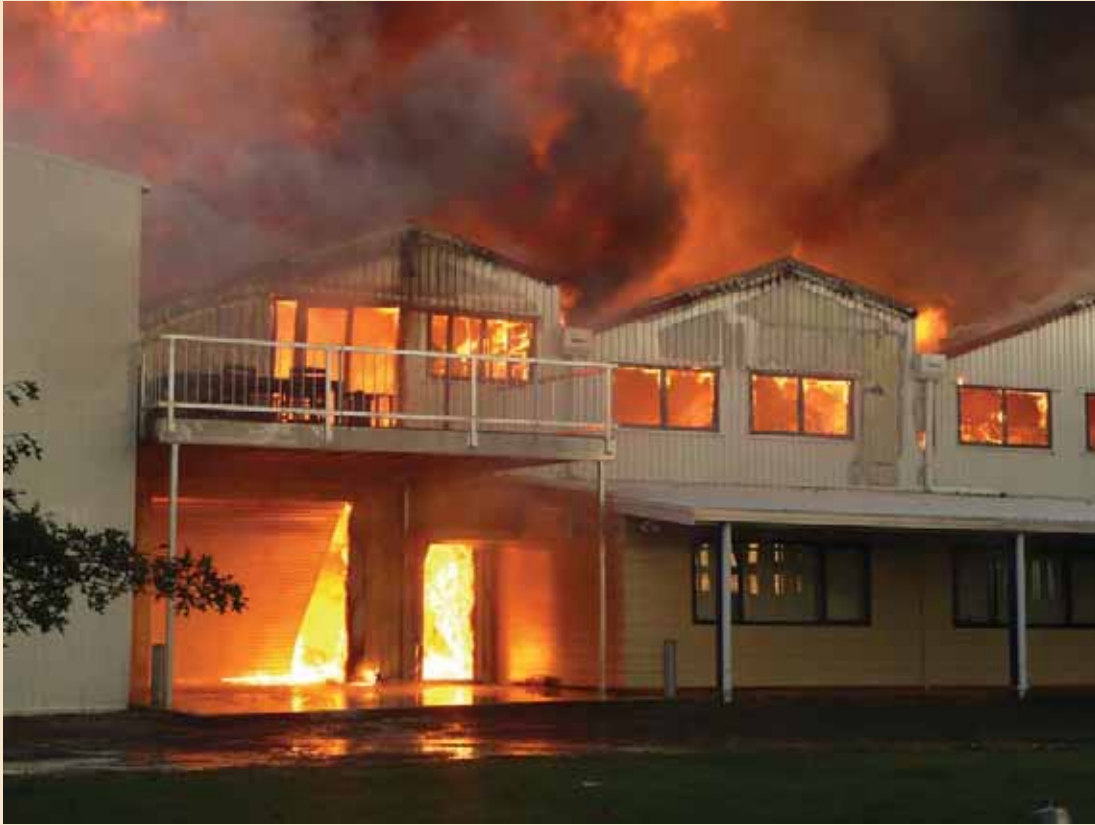
**Figure 17: The office building fully involved at 18:40**

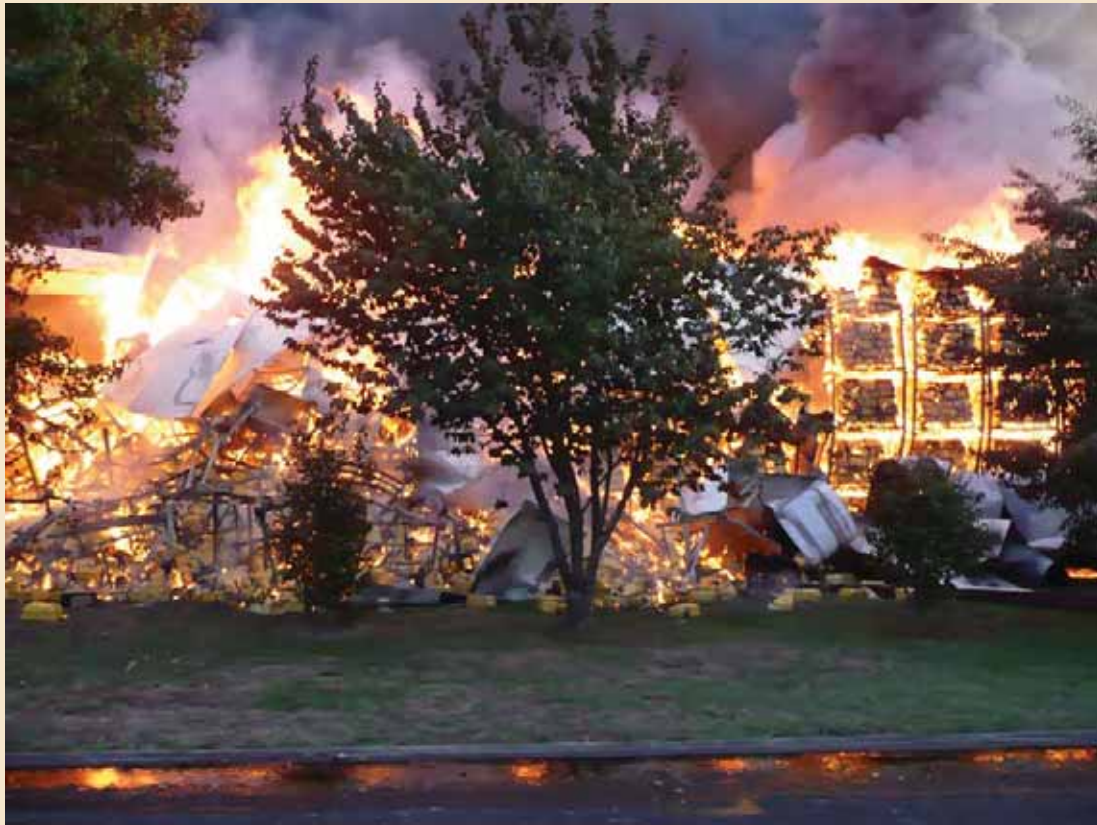
Source: New Zealand Fire Service

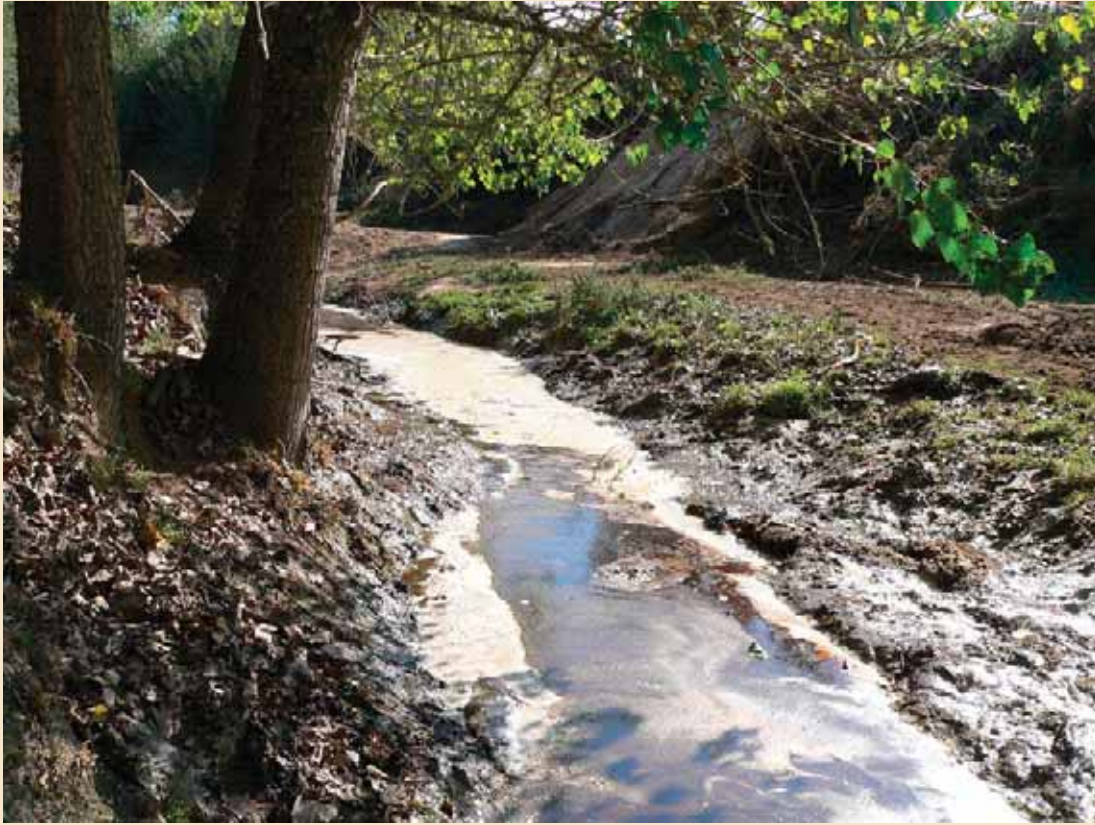
Source: Jonathan Caldwell Pictures

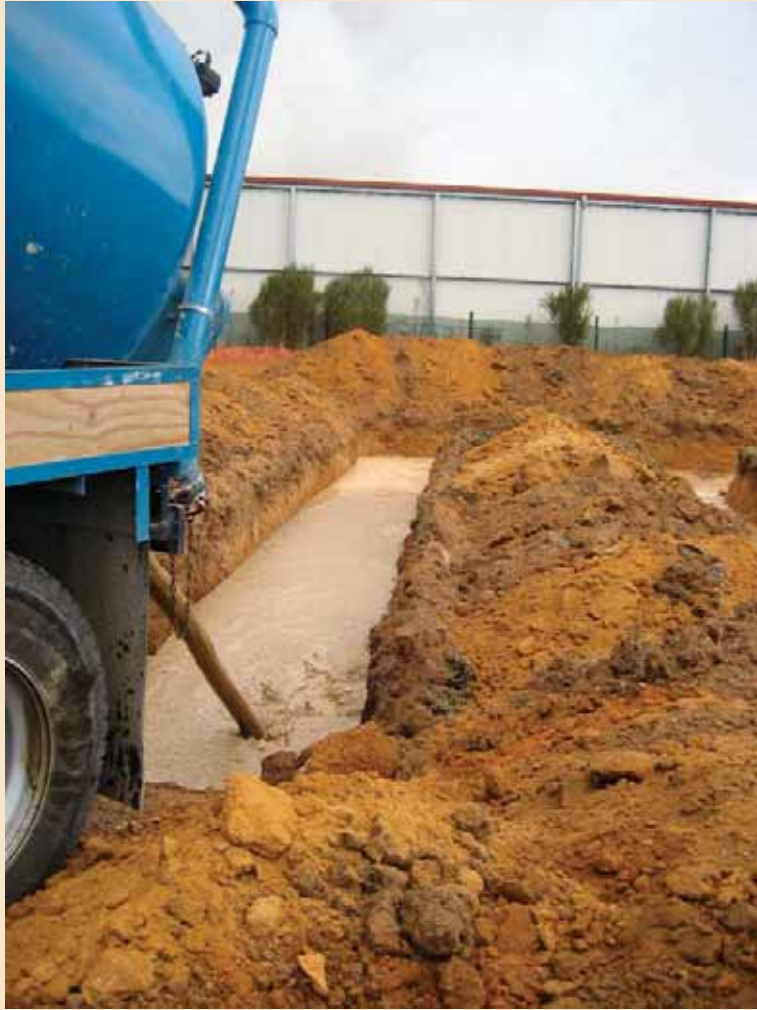
**Figure 23:**  
Sucker truck discharges  
into trenches dug in  
paddocks adjacent to  
Icepak facility

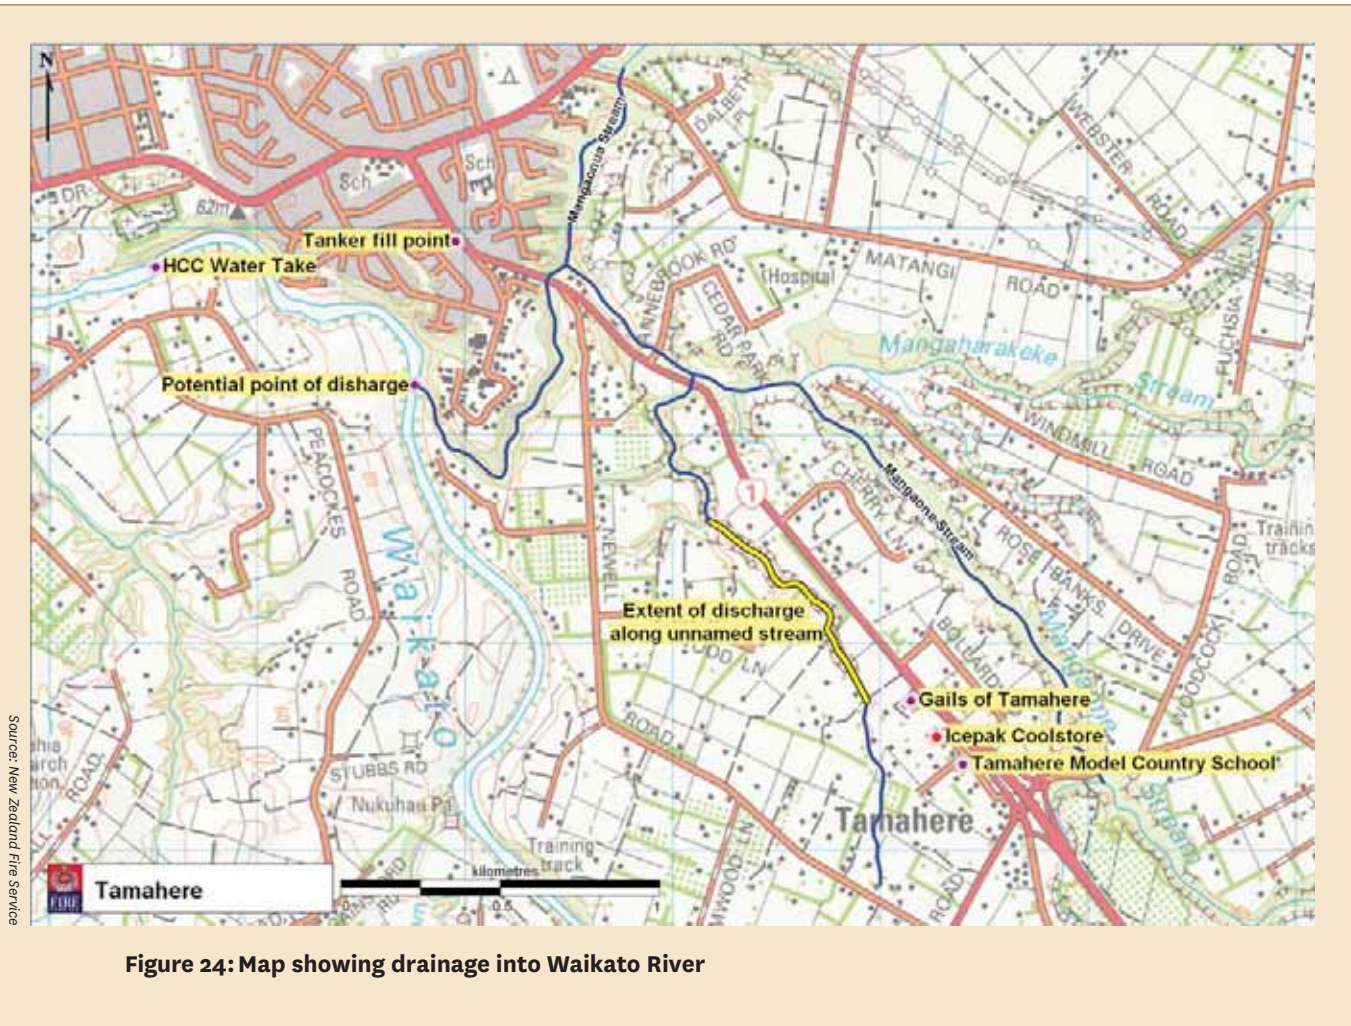
**Figure 24: Map showing drainage into Waikato River**

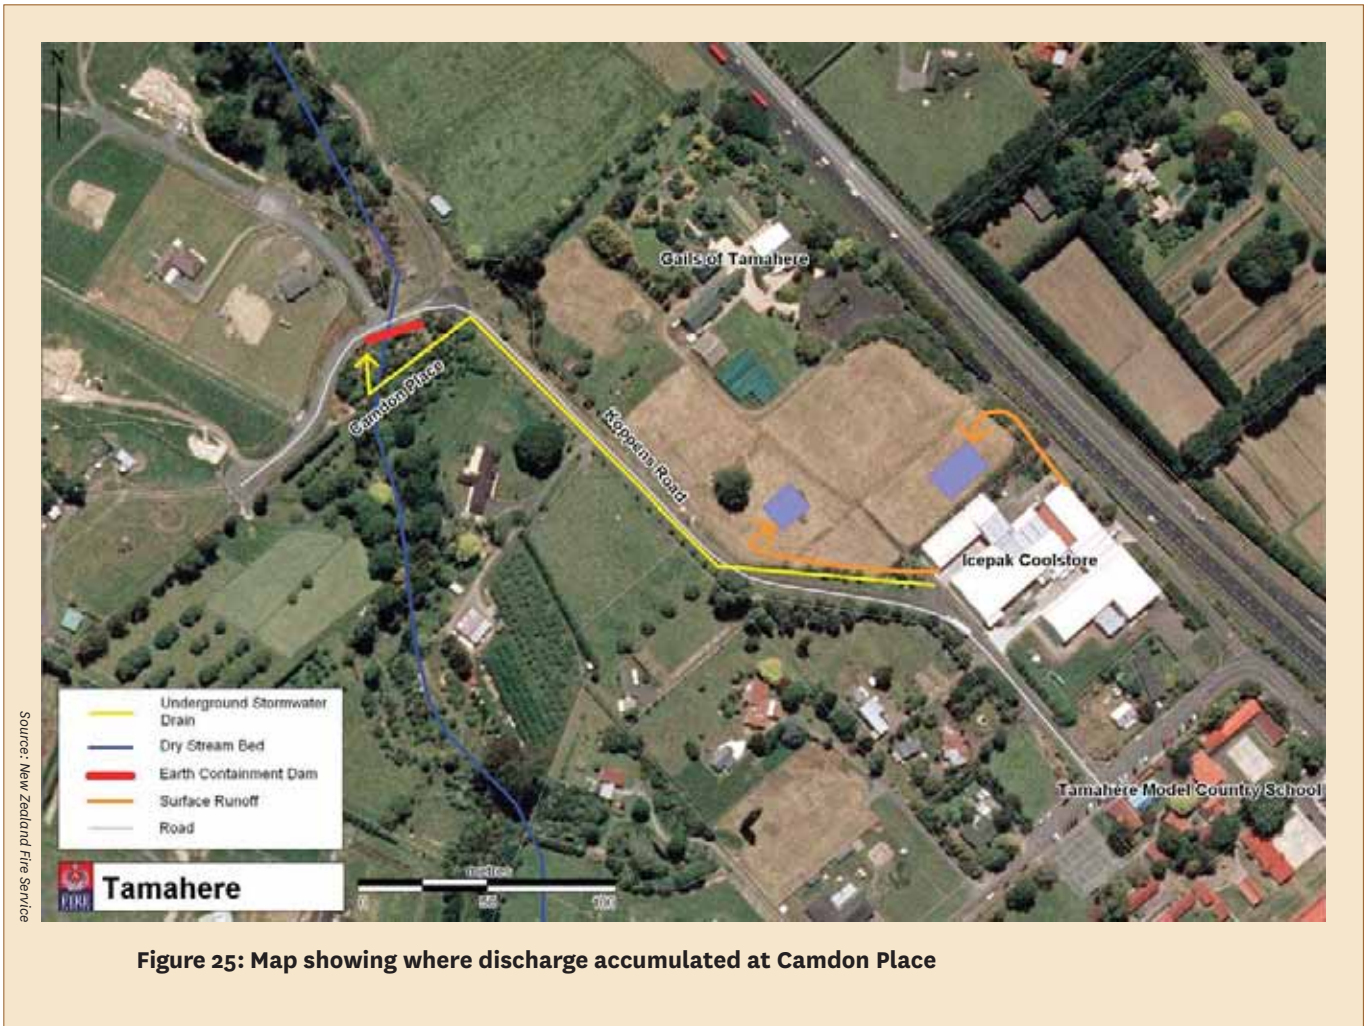
Some discussion took place between the parties about the nature of the airborne products of combustion. Advice was provided that the products burning were organic rather than hazardous substances and that the smoke was not a significant threat to the public, the key products being smoke particulates, carbon monoxide, acid gases, soot, and oil residues.

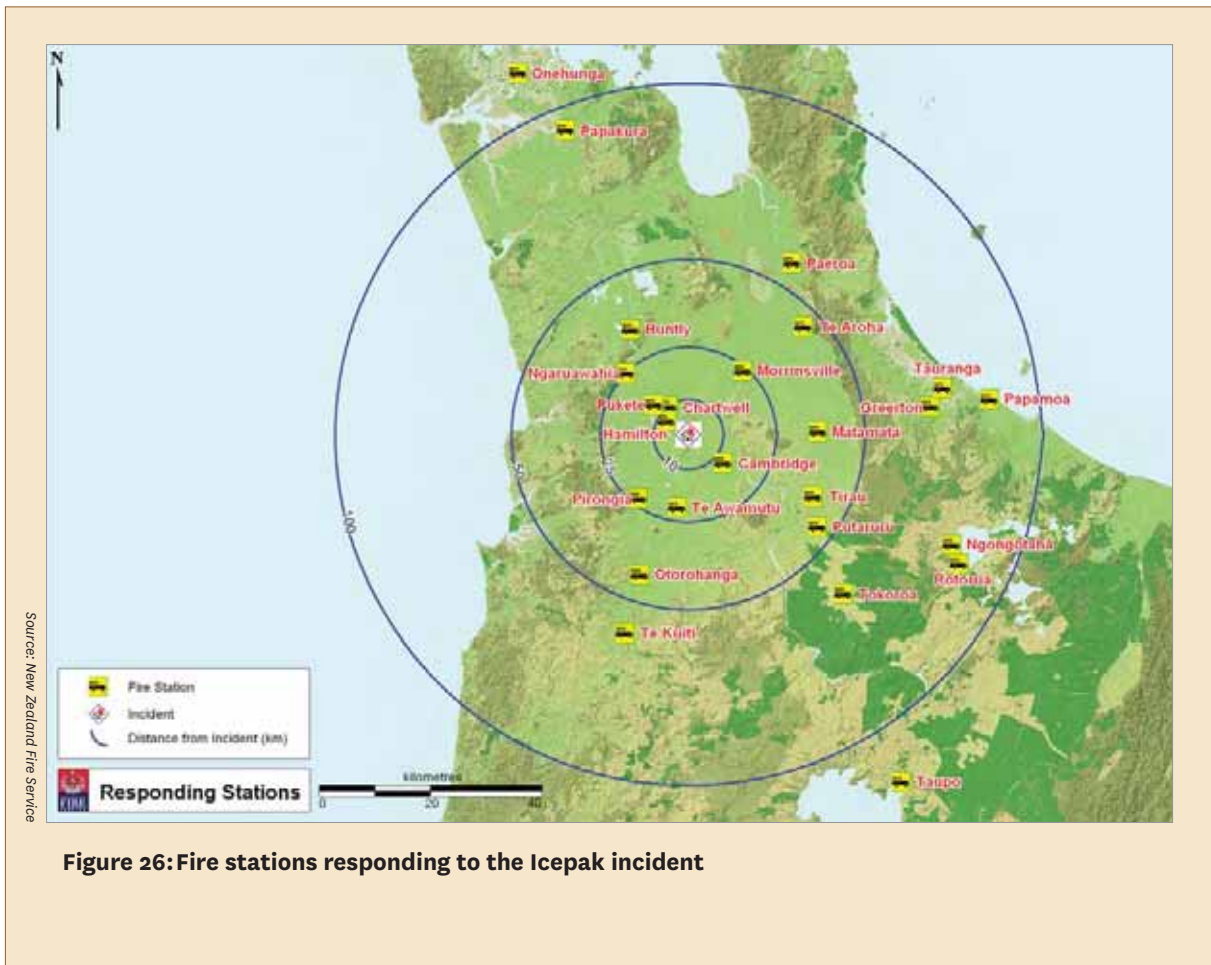
**Figure 26: Fire stations responding to the Icepak incident**

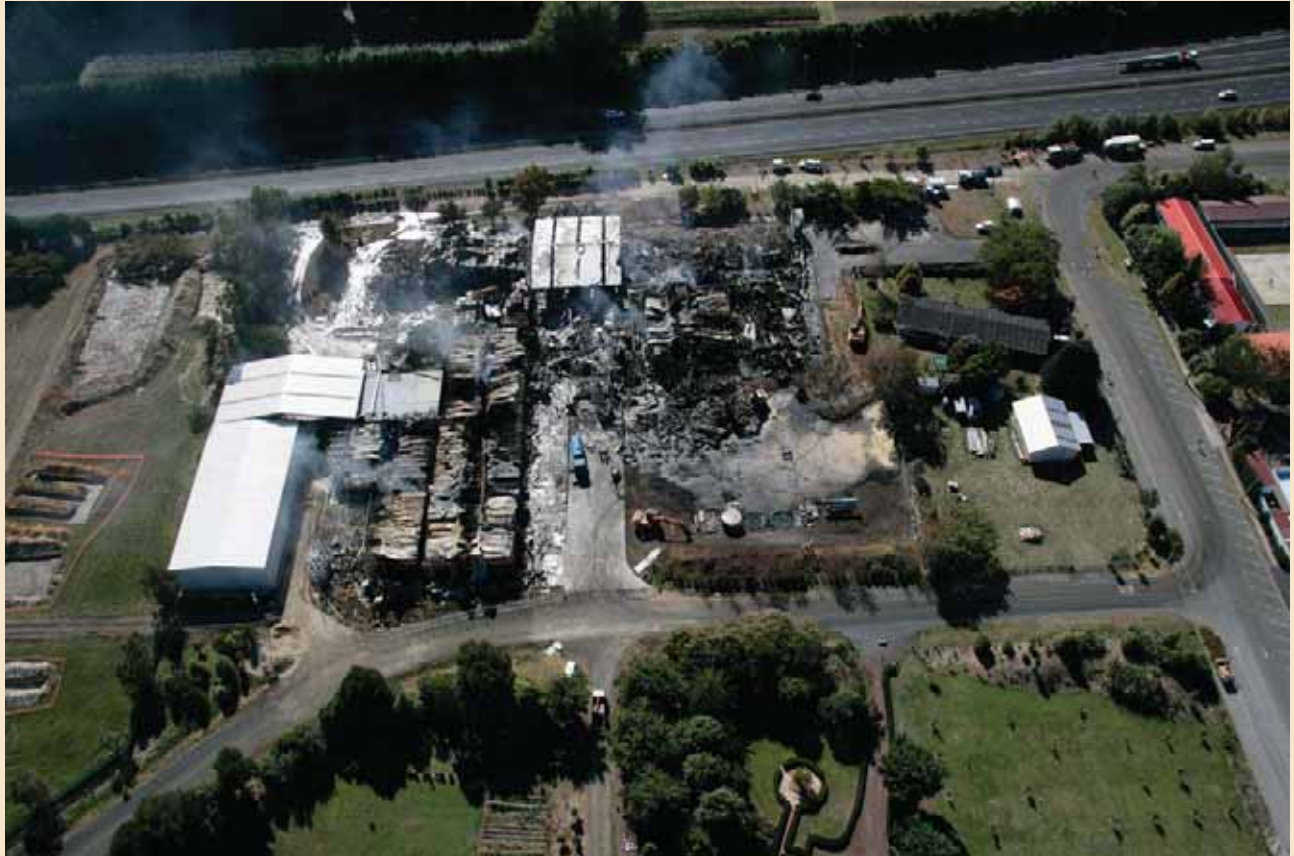
Source: Investigation Team

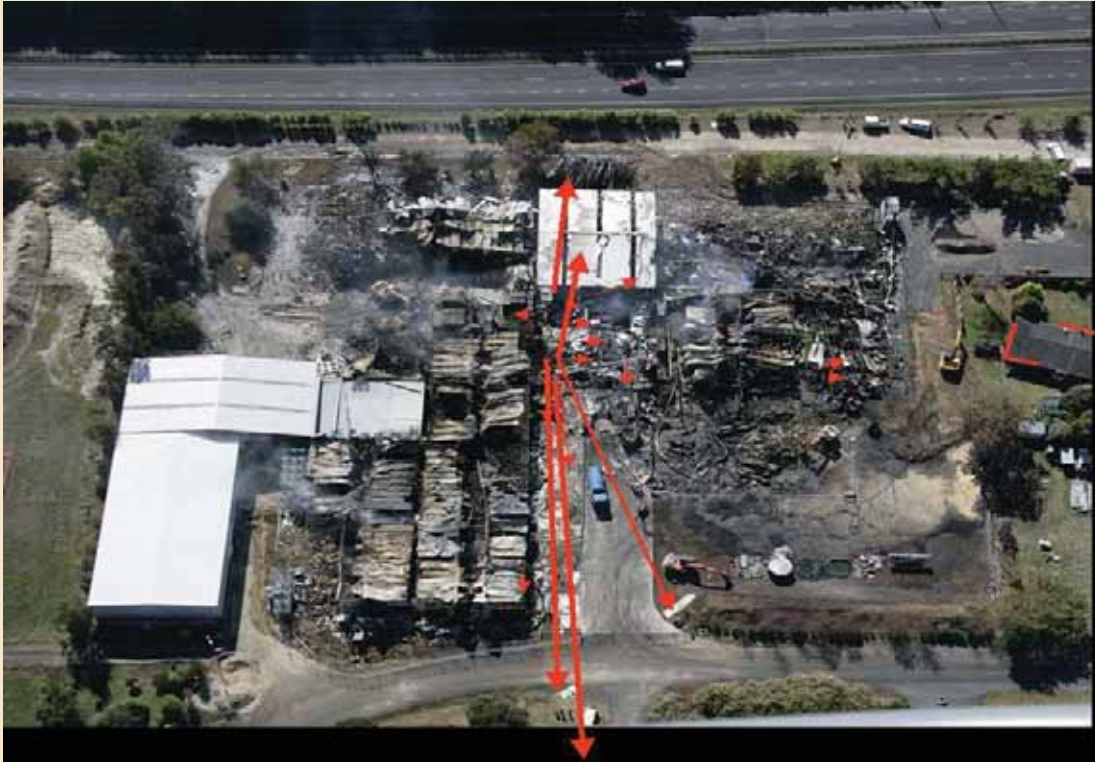
**Figure 28: Aerial view of site showing calculated force vectors**  
Plant room panels are lodged on the canopy.

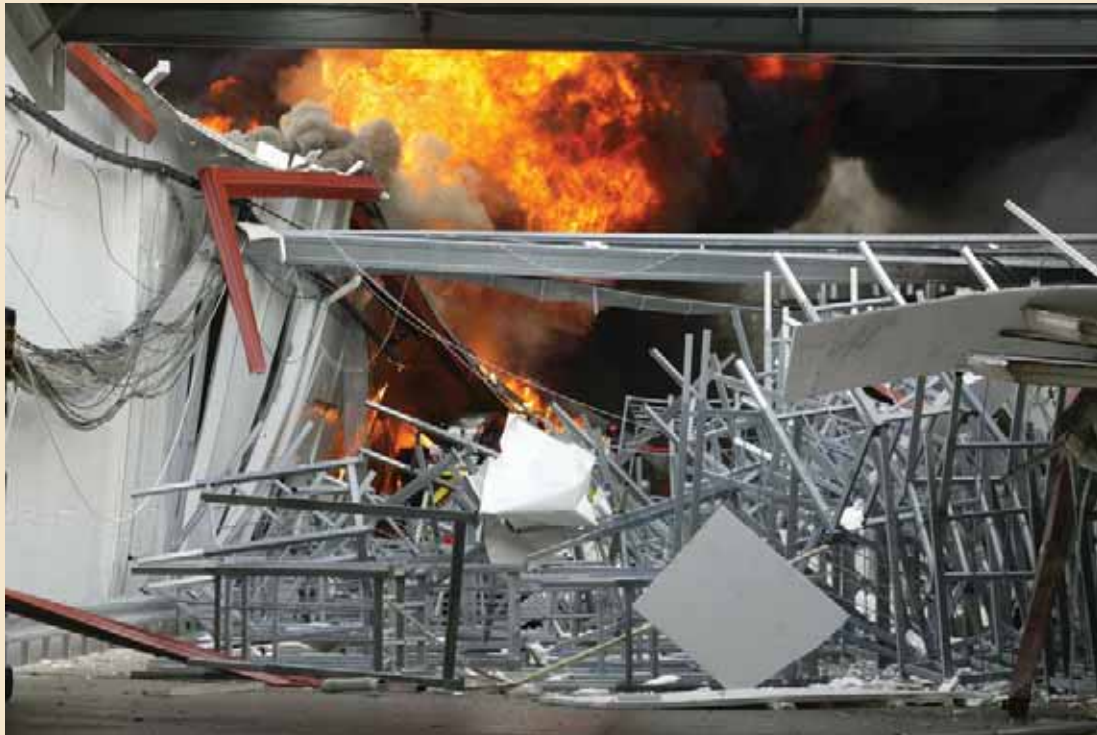
Source: Christine Cornege, Waikato Times
