# **Inquiry into the Explosion and Fire at Icepak Coolstores, Tamahere, on 5 April 2008**

**Incident Number F128045**

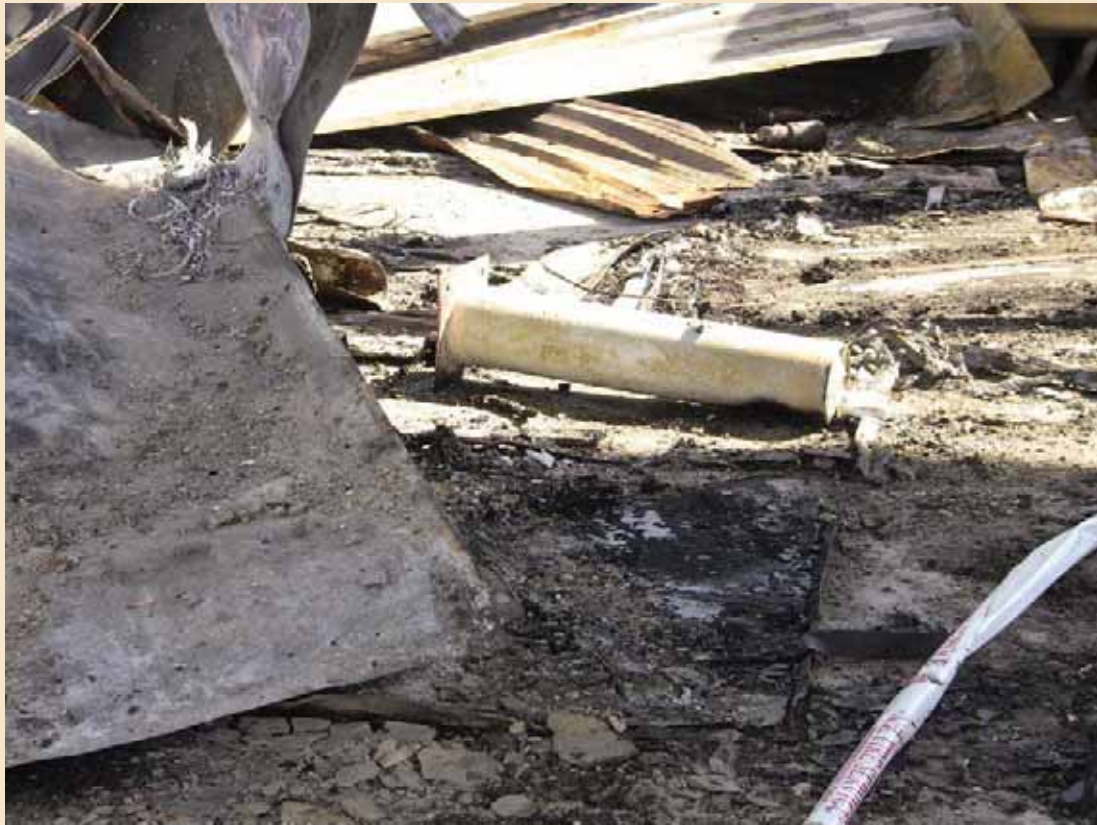
Source: Investigation Team

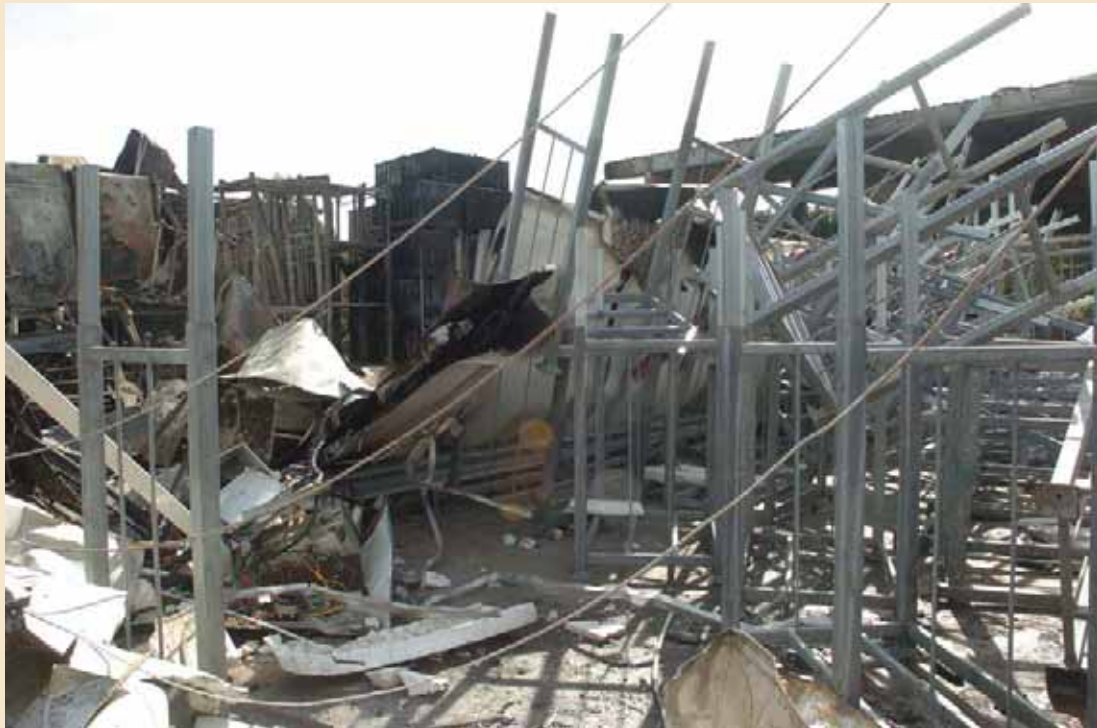
Source: Investigation Team

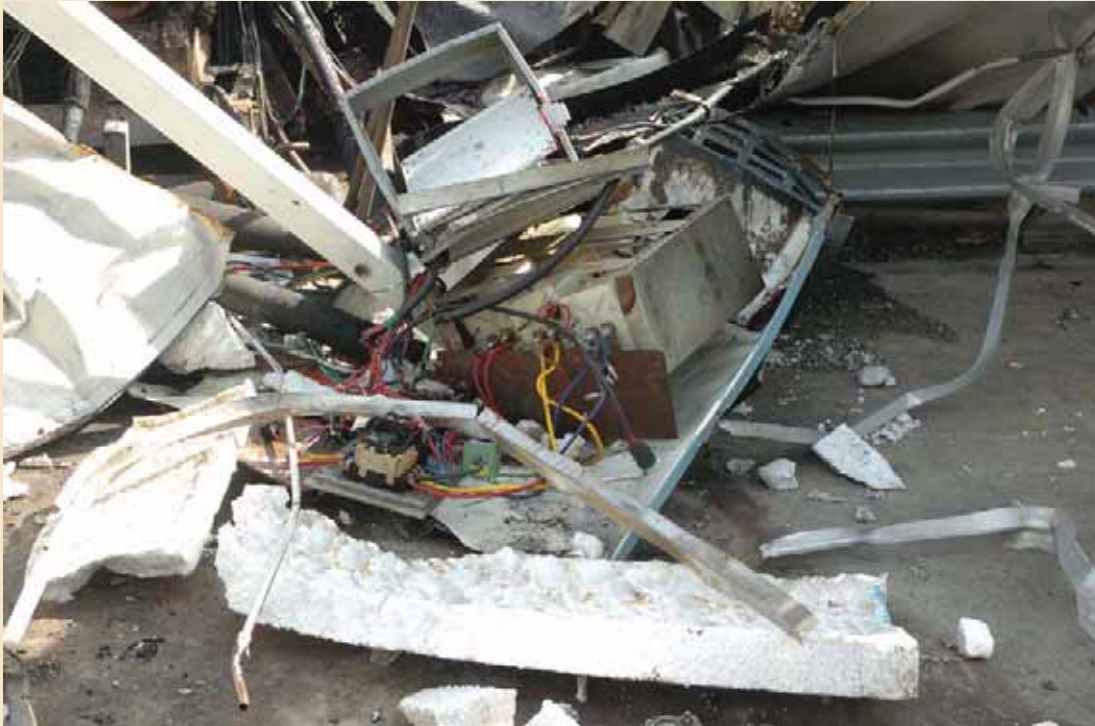
**Figure 34: Electrical equipment from Plant Room 1 in location, close up**

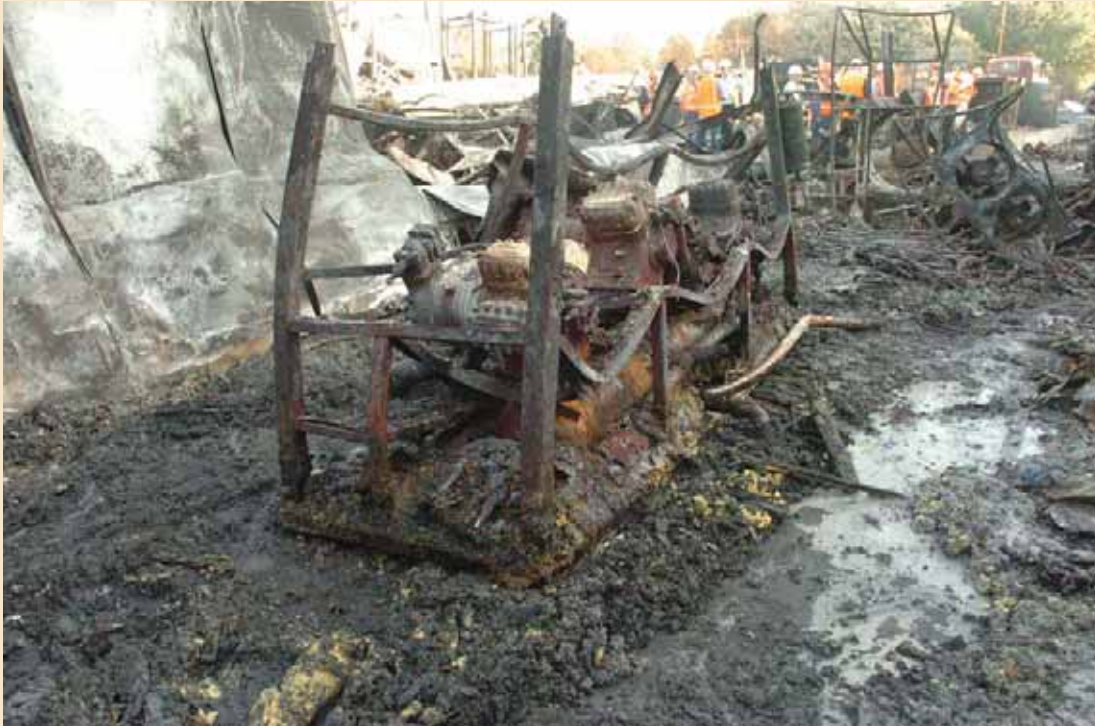
Source: Investigation Team

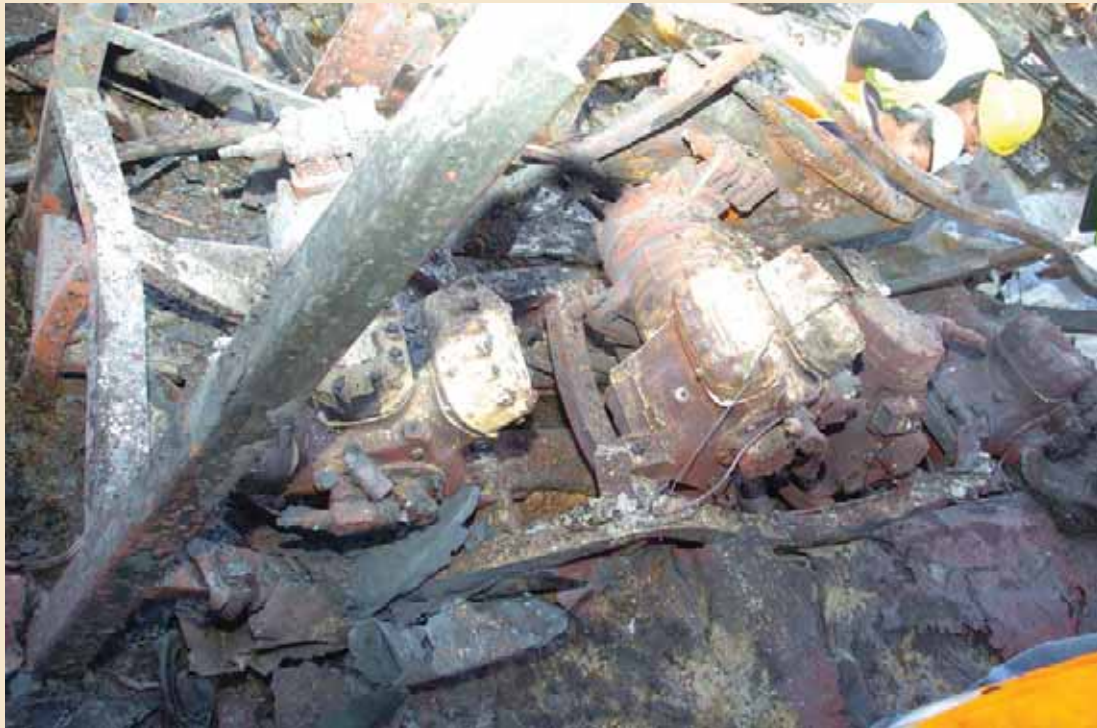
Source: Investigation Team

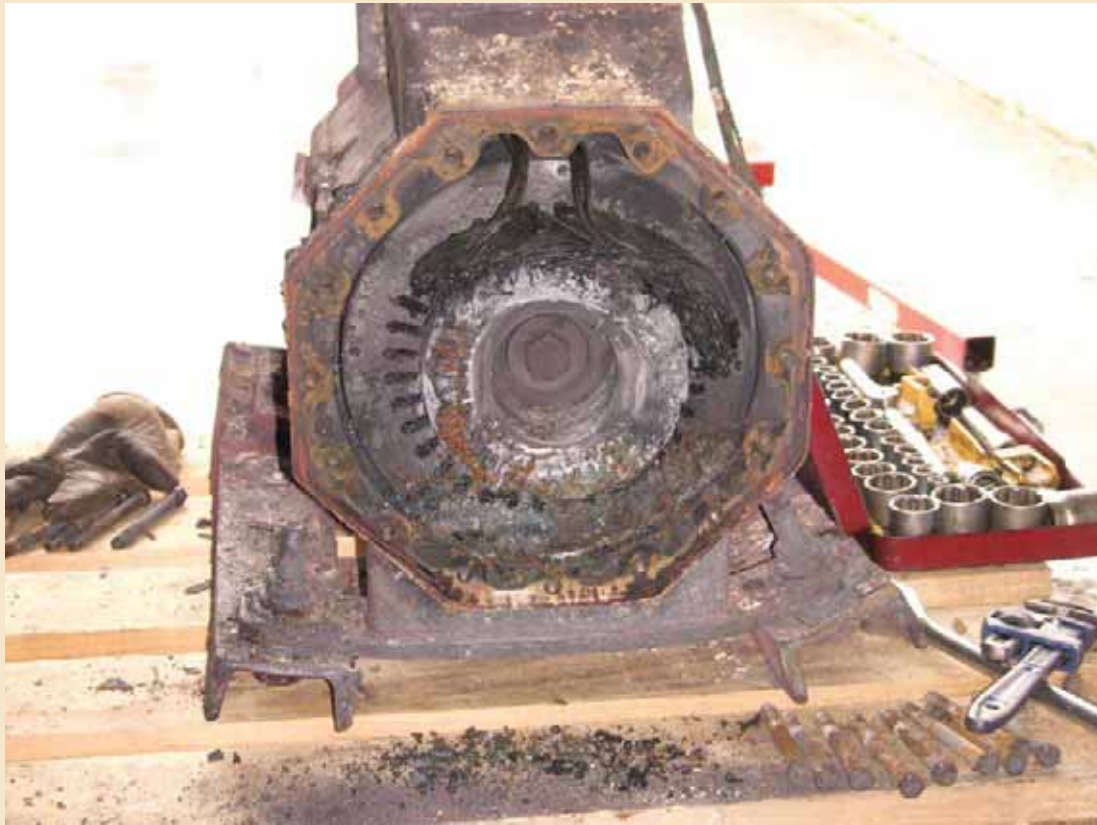
Source: Investigation Team

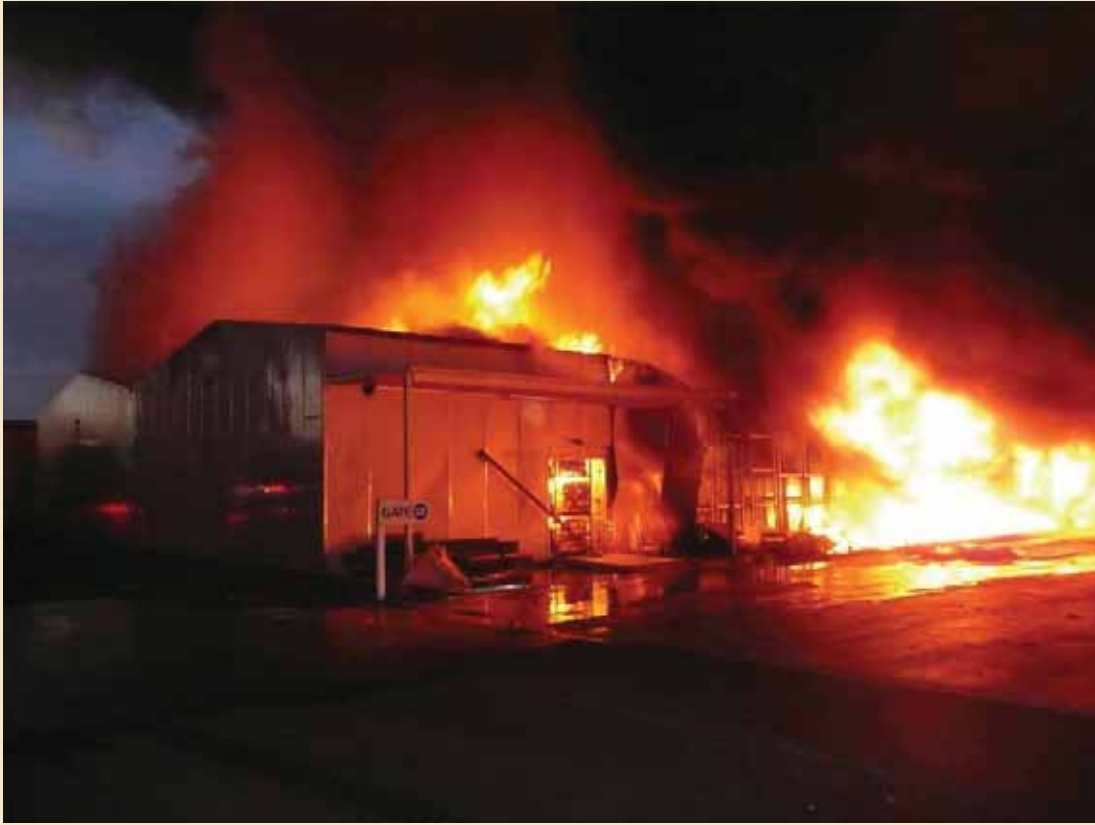
**Figure 41: West Room involved in fire, 17:25**

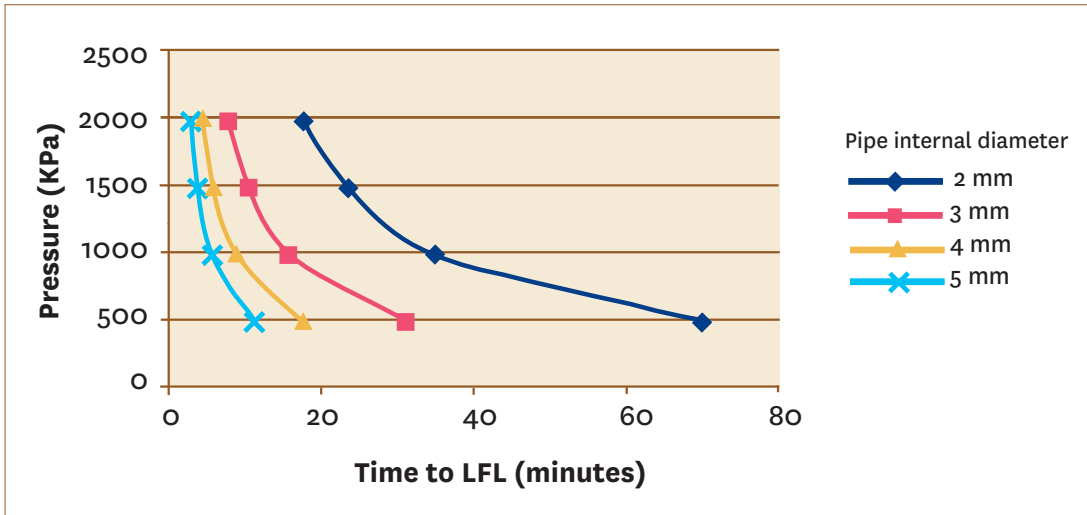
Figure F1: Times for build up of an explosive atmosphere in the plant room (lower flammable limit)
