Idaho State University (ISU) arena inspection. Located in Pocatello, ID, ISU is the region's largest university system serving residents of Idaho, Wyoming, Utah, Montana and a host of other states and countries. Its location serves to add to the difficulties of maintaining athletic facilities like this one – the northern Rockies can be, at times, a harsh climate for both winter and summer. I'm somewhat surprised it wasn't covered in snow when I went to do the inspection.

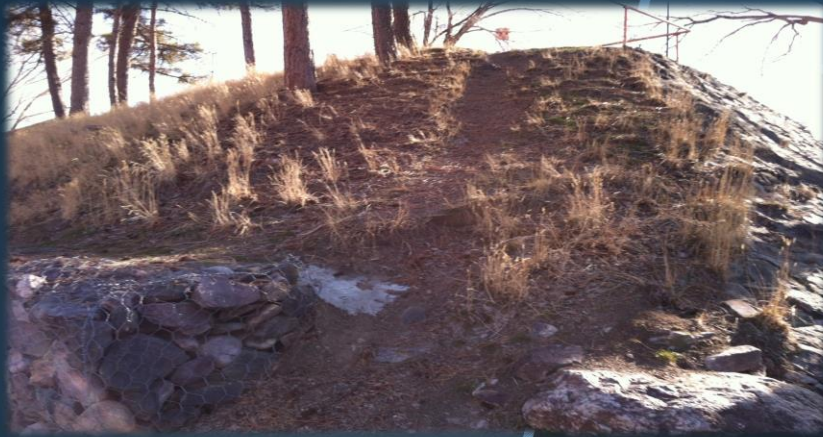
Undesignated walking path
that presents a hazard

While it may not be apparent from the photo, there is a well marked footpath that runs down this hill – the bleacher section of the track is just to the right of the picture and there is a significant grade to the slope. The hazard is that it is a steep slope, with no means to control the walking surface are access to it. It is obvious that this path is used frequently, but there seems to be nothing done by the university to control or restrict its use. The problem is that the path can become muddy/slick with sleet and snow, thus creating a slipping hazard for anyone who attempts to use it. My suggestion to restrict its use would be to construct a barrier to channel people away from it. Should this not be feasible – and surely it would be – perhaps add some landscaping and signage to prevent people for being attempted to use it. Also, on the backside of the hill is a steep drop-off that is of concern to me, but I'll get to that in the subsequent slides.

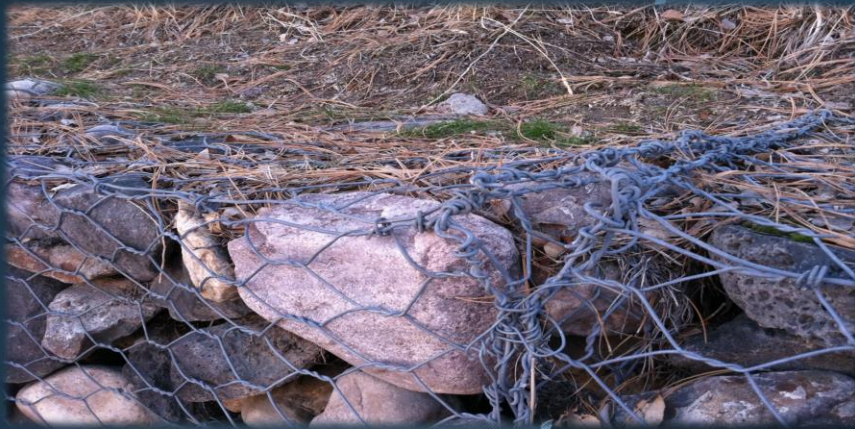
Retaining fencing that
protrudes into walkway

Again, while the picture doesn't apparently show the hazard, there is a significant one present. Along the main walkway leading to the bleacher section of the arena there is a retaining wall made of stone that is held in place by fencing. This fencing, in many places along the way, protrudes out into the walkway, creating a snagging hazard, and in the case of smaller people, a puncture hazard. This is significant in that it could result in an injury and is easily remedied. All one would need to do is either substitute something safer for the fencing, or do away with it altogether. If these two options aren't available, then perhaps more should be done in the way of ensuring the fencing is well maintained and not a hazard to those visiting the arena.

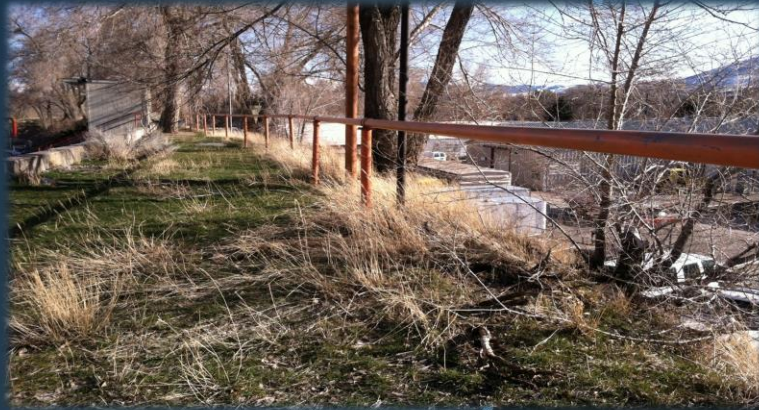
Guard railing atop the
bleachers is inadequate

The picture doesn't fully show the hazard here, but there is one present. For example, just beyond the railing is a steep 10-15 foot drop-off onto concrete. The railing is approximately 36 inches tall, with no mid-rail. The problem here is children. It would be very easy for a child under this height to walk under the railing and fall to the concrete below. The bleachers are to the left in the picture – where most people would be facing the track and field – and should a child wander to the edge of the bleachers, they'd be exposed to the fall. To correct this, I would suggest that the university either add more railing or construct a barrier that would prevent those who could possibly do so from falling to the concrete below. Also, perhaps more grounds-keeping is in order to ensure a more suitable surface.

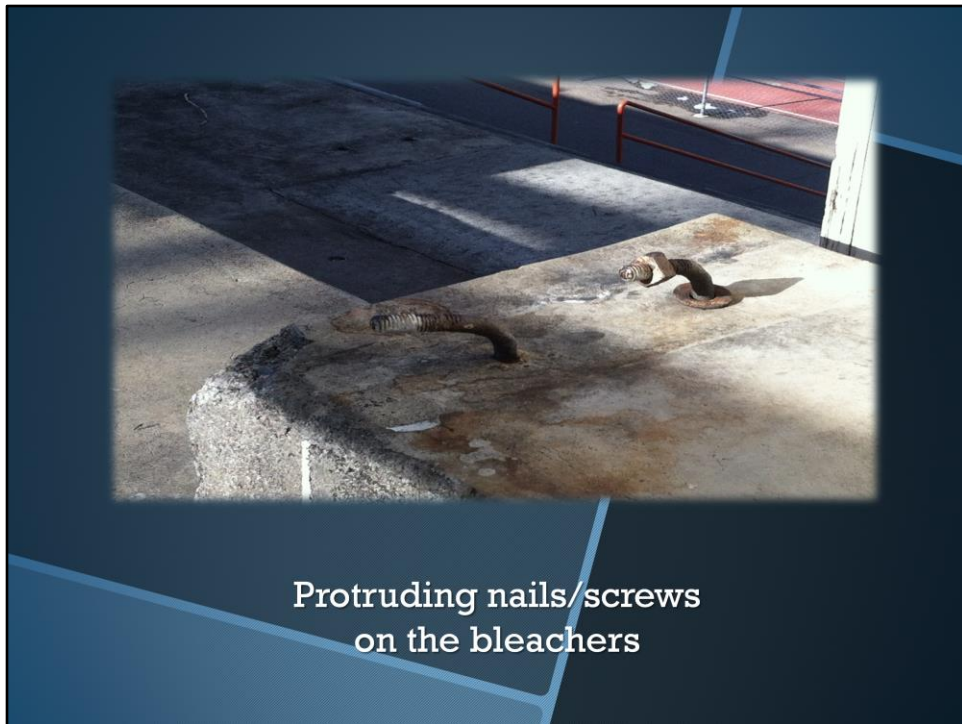
This is an obvious hazard that should not be present at a facility used as often as this. Apparently, the solution to this problem was to simply hammer the protrusions to an angle thought acceptable by those sitting in the bleachers. However, I don't agree with this. They should be removed if they serve no other purpose. Doing this would completely eliminate the hazard and provide a safe area for those to view the activities on the field.

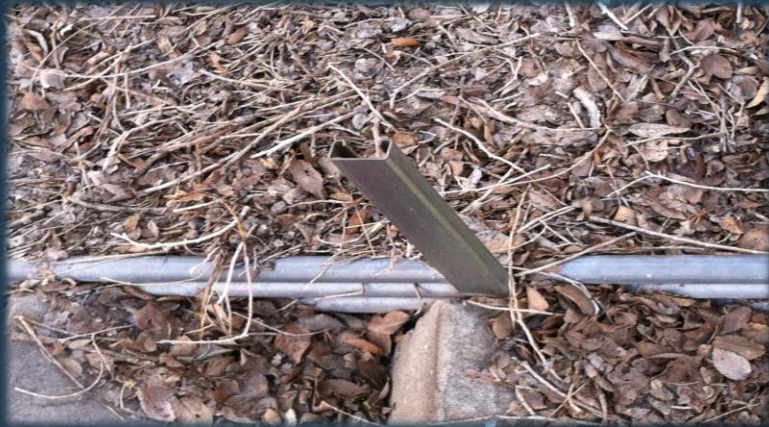
Impalement hazard
along the steps of the
bleachers

This hazard was right in the path of those utilizing the steps of the bleachers. There is no handrail or any other means of assistance when using the steps. I've no idea what it's even doing here, or what it could possibly be used for – it seems there was something once upon a time, but now all that remains is this obstruction that could easily turn into an impalement hazard. It should be removed, immediately. And if this is not an option, it should be returned to its proper function or guarded against possible injury.

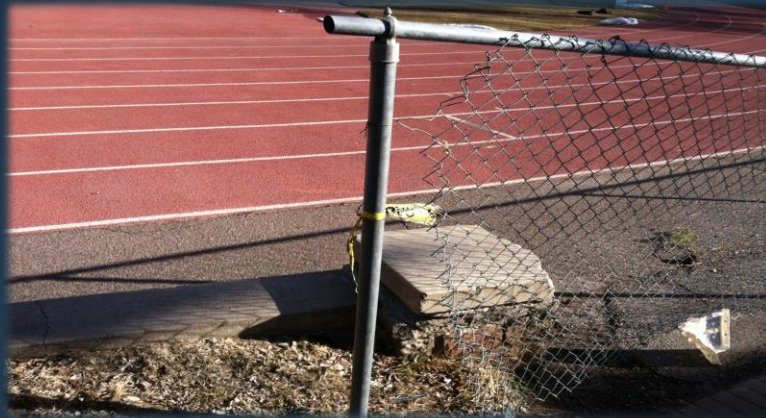
Entanglement hazard

Children frequent this arena, and because of this, issues such as this should be remedied without delay. This fencing is in need of repair – it hangs in the walkway creating a puncture hazard and an entanglement hazard for all those who may perchance walk by it. It wouldn't be a difficult fix, simply install the fencing properly and ensure that it stays that way.

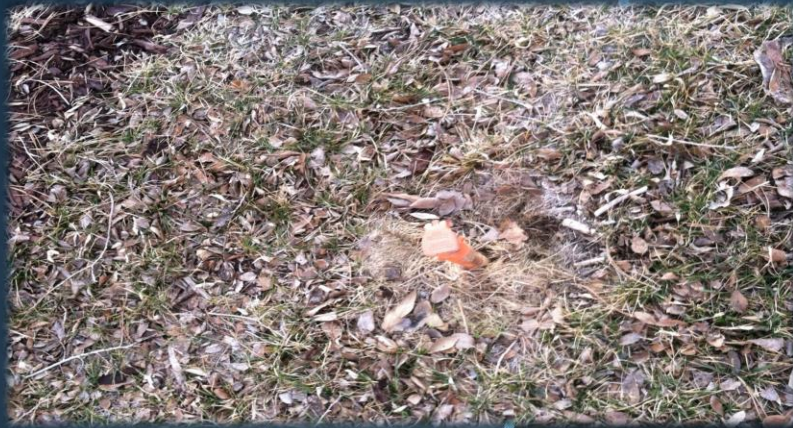
Tripping hazard just off
the walking path

This tripping hazard should be guarded against. While the university did take the step of painting the protrusion, more needs to be done. This hazard is literally just off the main walking path of the arena, and could easily be tripped over. They should construct a barrier around it so as to prevent anyone from tripping over it.
